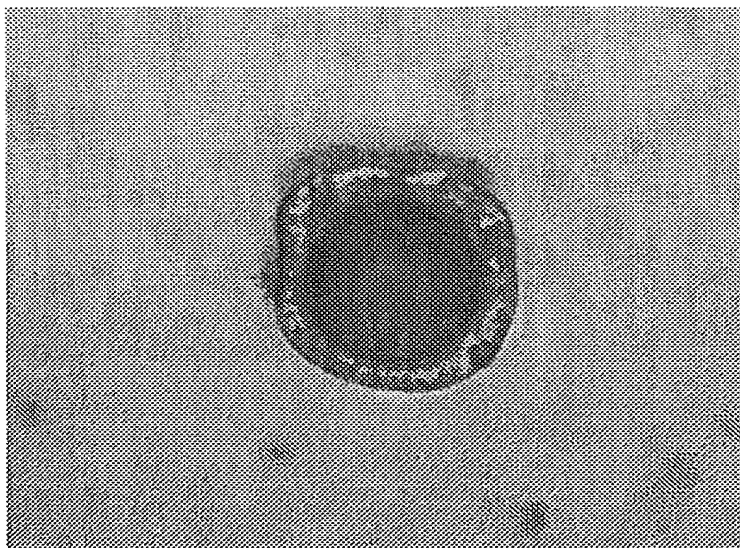
Figure 1: Silver plated copper time zero pull test - breaks at first ball bond.

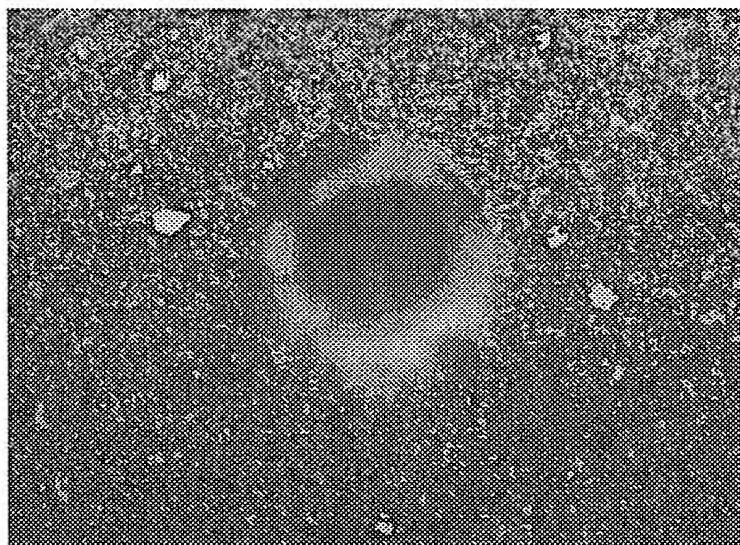
Figure 2: Silver plated copper HTS (150 degrees Celsius) 240hr pull test - breaks at first ball bond.

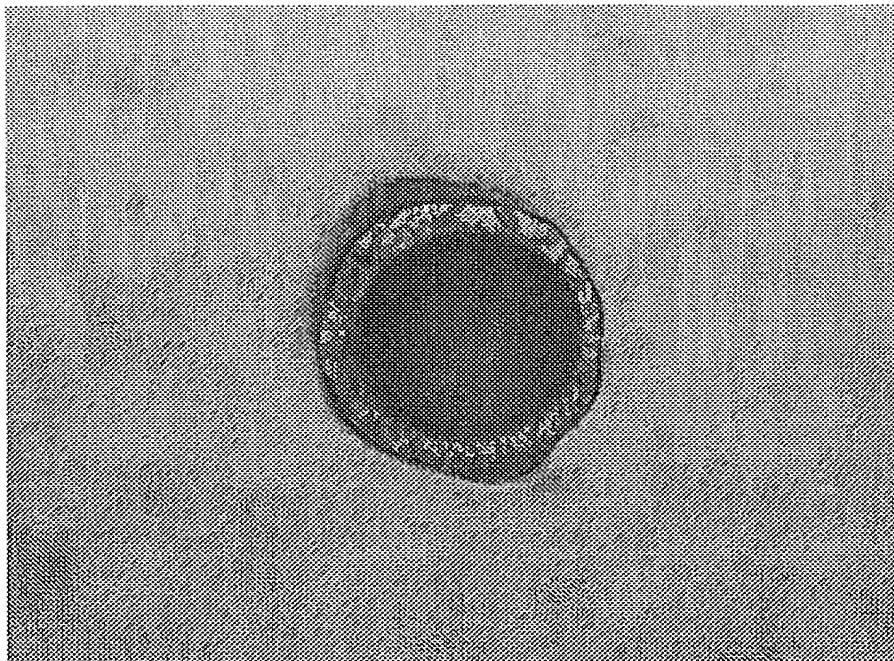
Figure 3: Silver plated copper 1xreflow pull test - breaks at first ball bond.

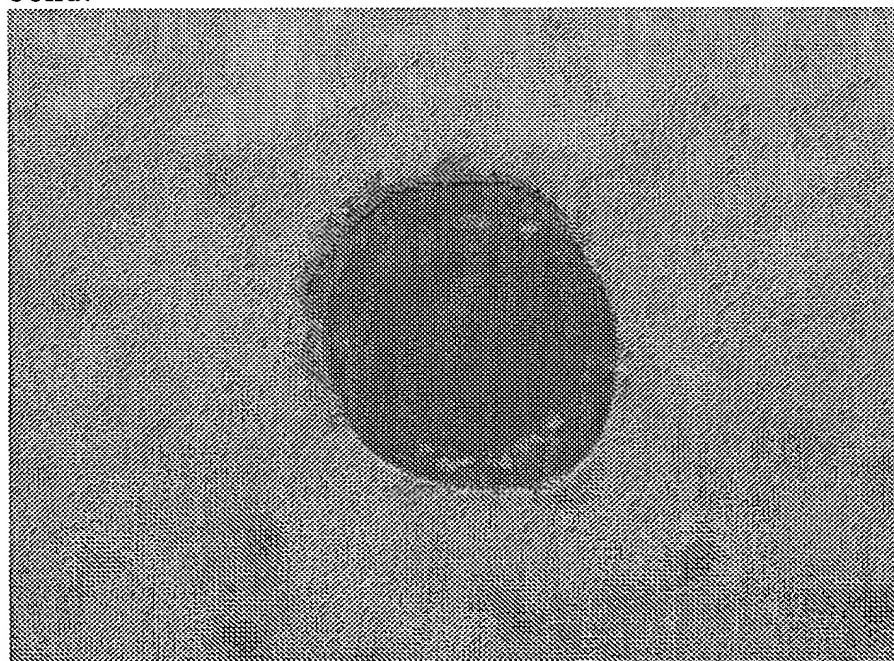
Figure 4: Silver plated copper 4xreflow pull test - breaks at first ball bond.
